FLOOD OF JULY 12-13, 2004, BURLINGTON AND CAMDEN COUNTIES, SOUTH-CENTRAL NEW JERSEY

Scientific Investigations Report 2006-5096

By Amy R. Protz and Timothy J. Reed

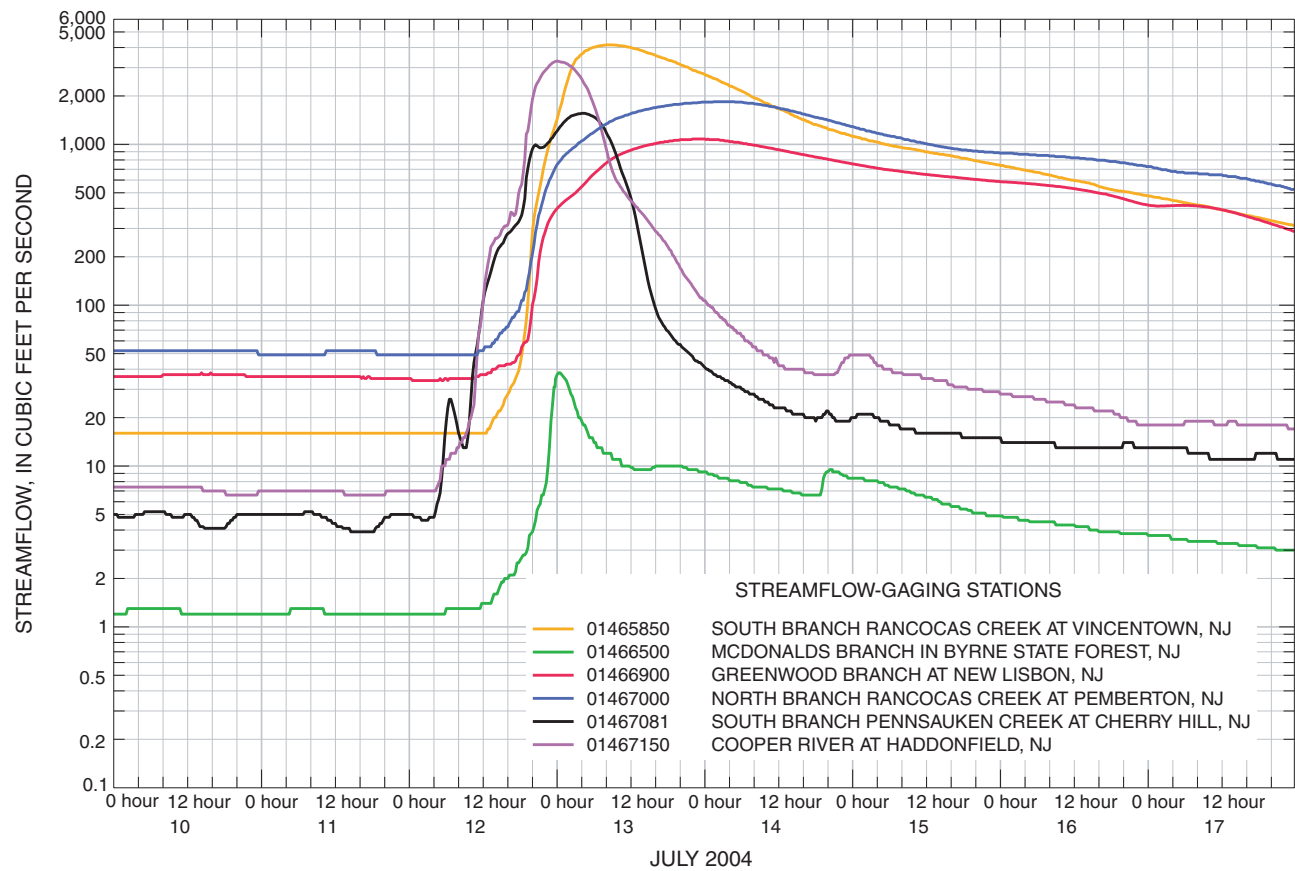
Figure 5. Hydrographs showing streamflow at six continuous-record stream gages within the Rancocas Creek, Cooper River, and Pennsauken Creek Basins, south-central New Jersey, July 10-17, 2004.

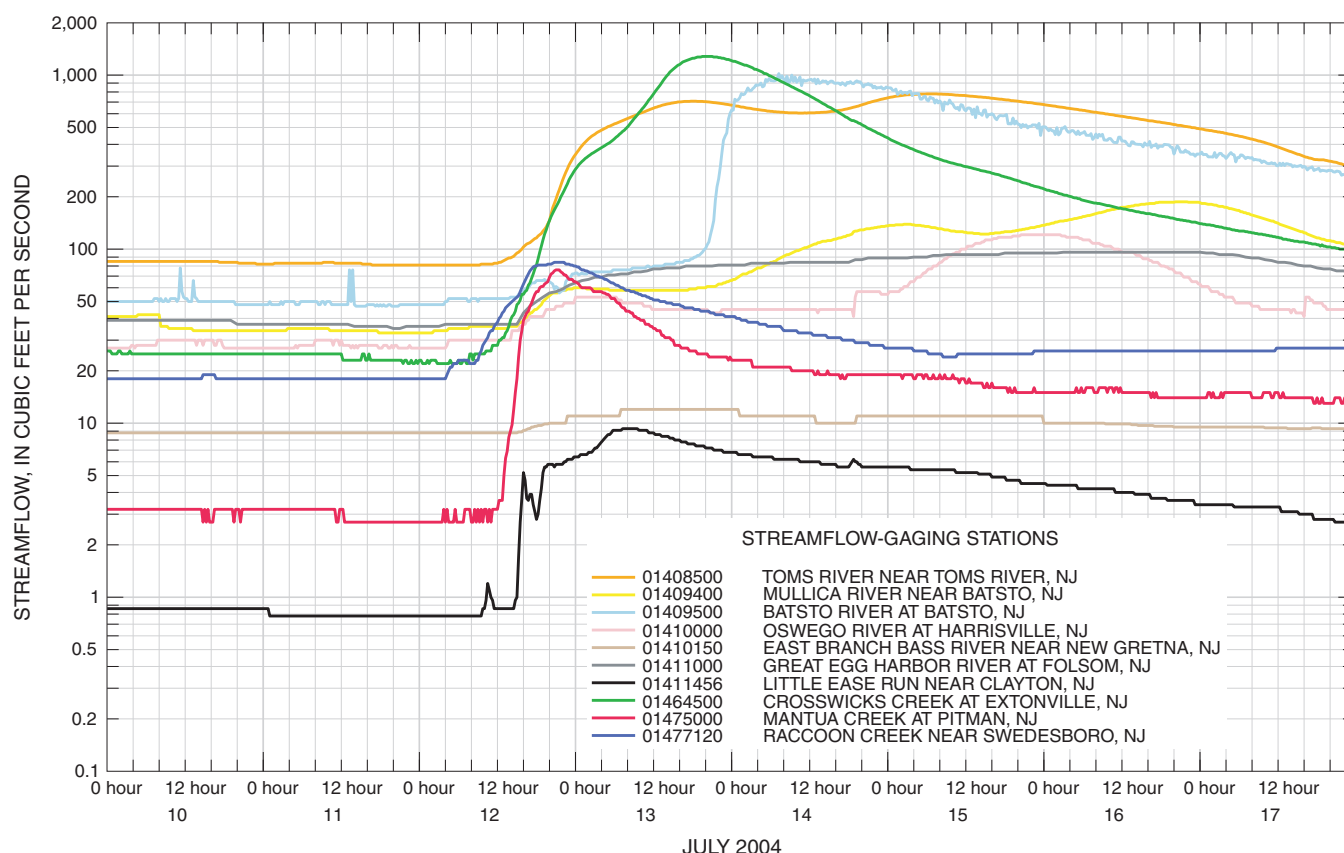
Figure 7. Hydrographs showing streamflow at 10 continuous-record stream gages surrounding the Rancocas Creek, Cooper River, and Pennauken Creek Basins, south-central New Jersey, July 10-17, 2004.

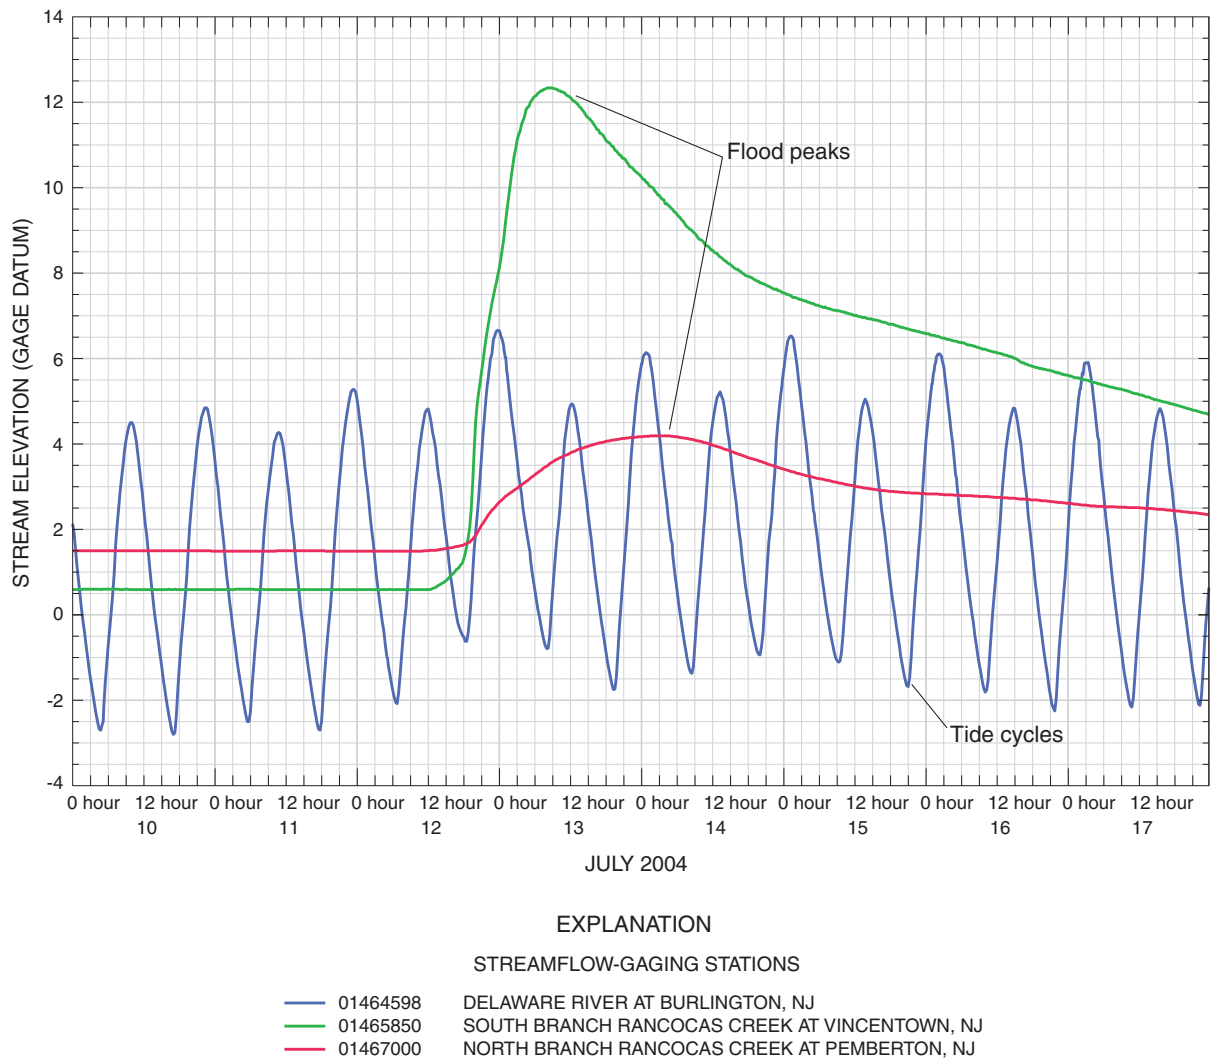
Figure 8. Tide cycles on the Delaware River and stream elevations on the North and South Branches of the Rancocas Creek at Pemberton and Vincentown, New Jersey, July 10-17, 2004.

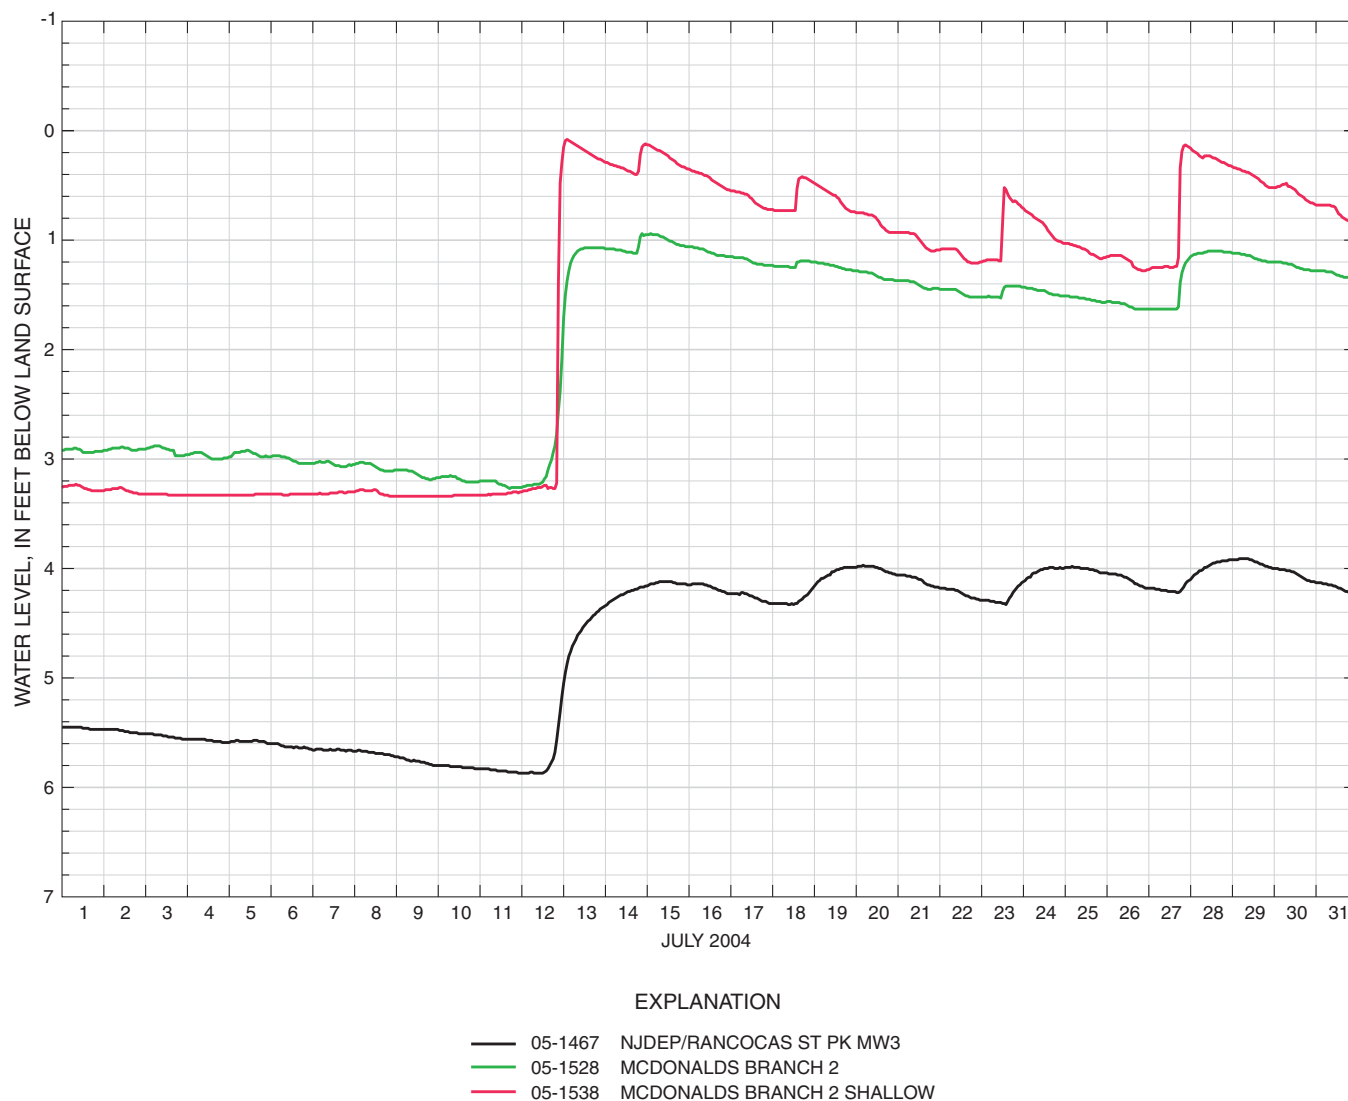
Figure 9. Water levels in three wells in the Rancocas Creek Basin, New Jersey, July 1-31, 2004.

The first well is located in Rancocas State Park, Hainesport Township, and is identified by the USGS as well number 05-1467. This well taps the Englishtown aquifer system of Cretaceous age. The well is 14 feet deep and is screened from 9 to 14 feet below land surface. Land surface is 17 feet above NGVD of 1929.

The second well is located in Brendan T. Byrne State Forest, Woodland Township, and is identified as well number 05-1528. This well taps the Kirkwood-Cohansey aquifer system of Miocene age. The well is 6 feet deep and is screened from 5 to 6 feet below land surface. Land surface is 121.09 feet above NGVD of 1929.

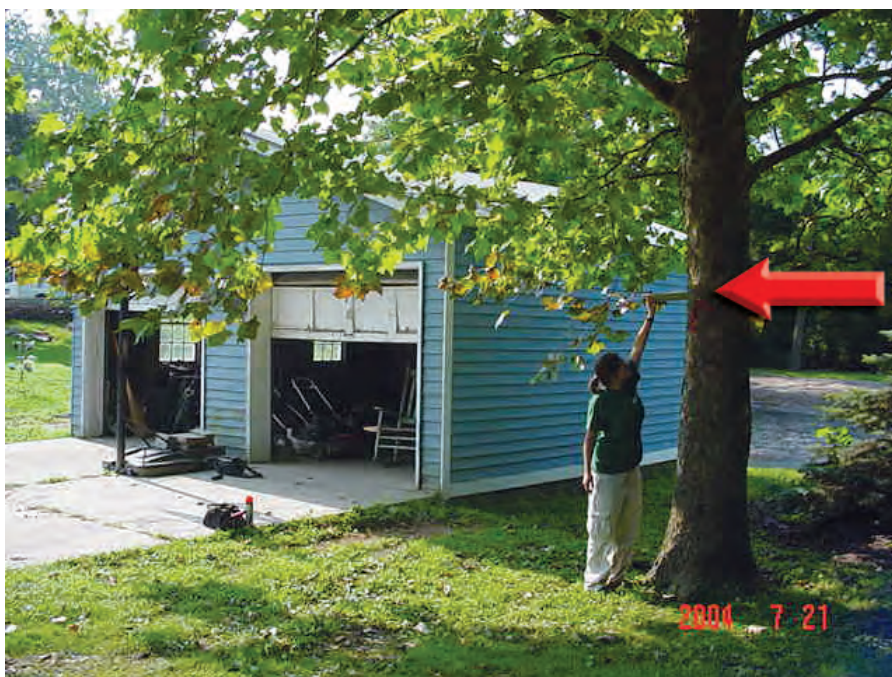
High-water mark on upstream left bank of South Branch Rancocas Creek at Lumberton, N.J. (SBR1).

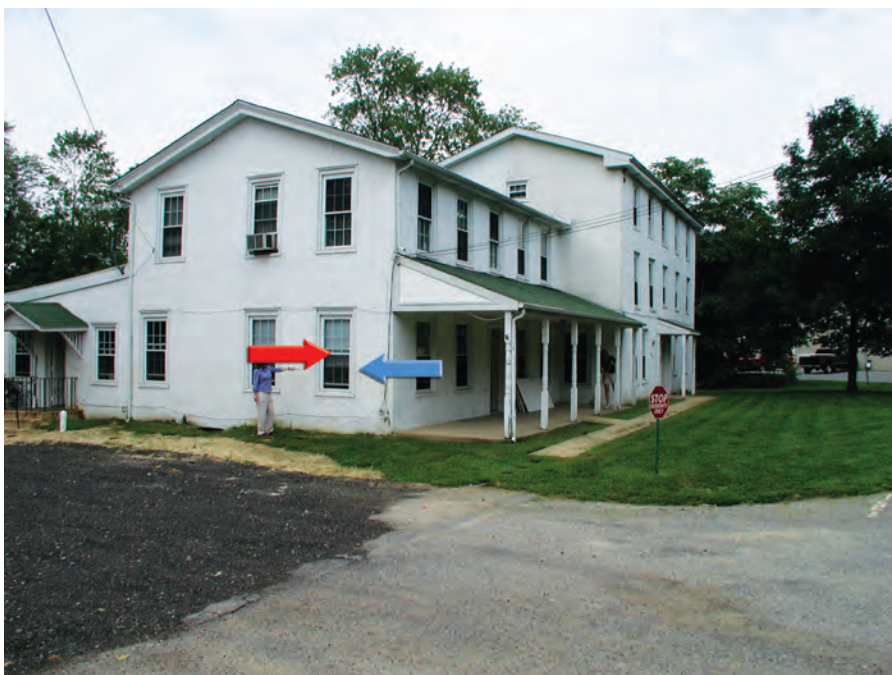
Former Lumberton Inn, Lumberton, N.J. Red arrow is height of 1940 flood; blue arrow is height of 2004 flood (SBR1).

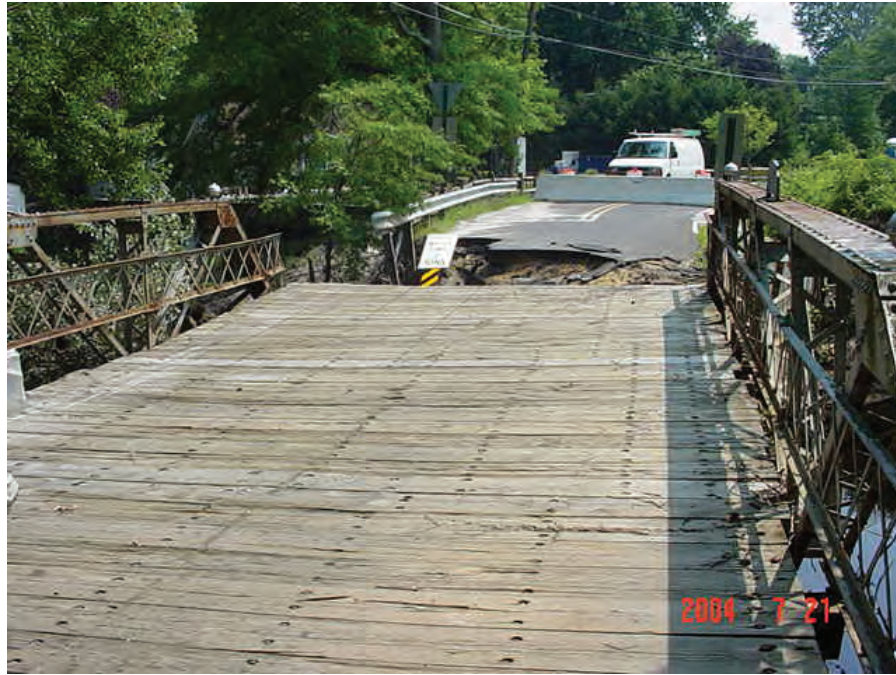
Damage to Hillards Bridge Road, at South Branch Rancocas Creek, Vincentown, N.J. (SBR6).

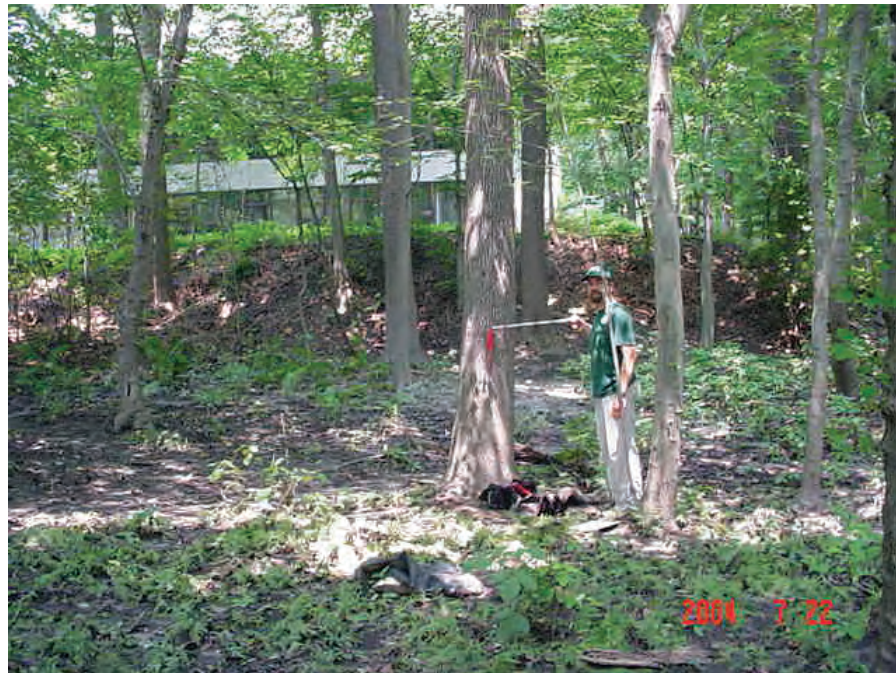
High-water mark on downstream, left bank of Haynes Creek at Oliphant Mills, N.J. (HAY1).

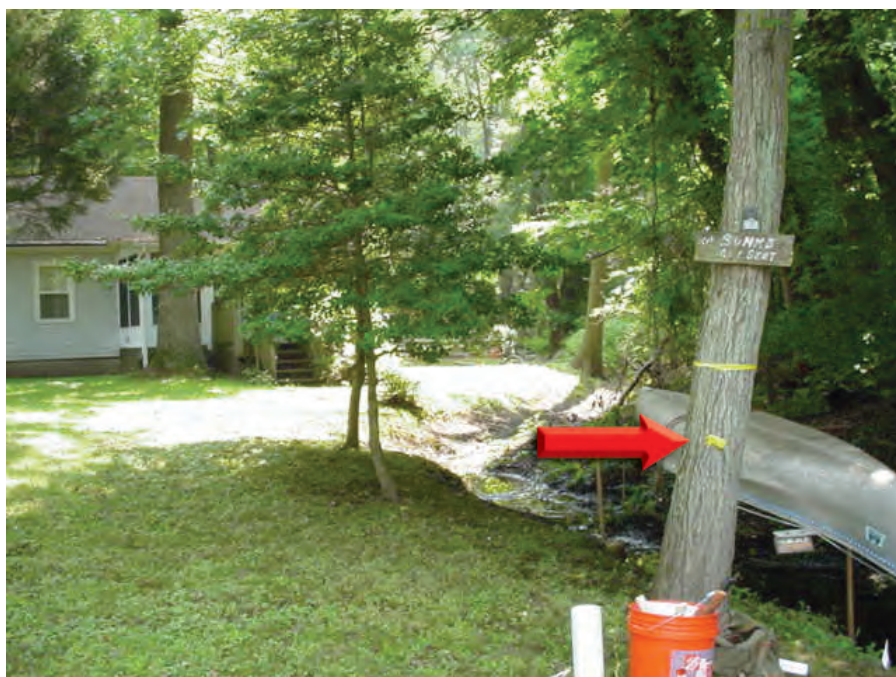
High-water mark on upstream, right bank of North Branch Rancocas Creek at Ewansville, N.J. (NBR3).

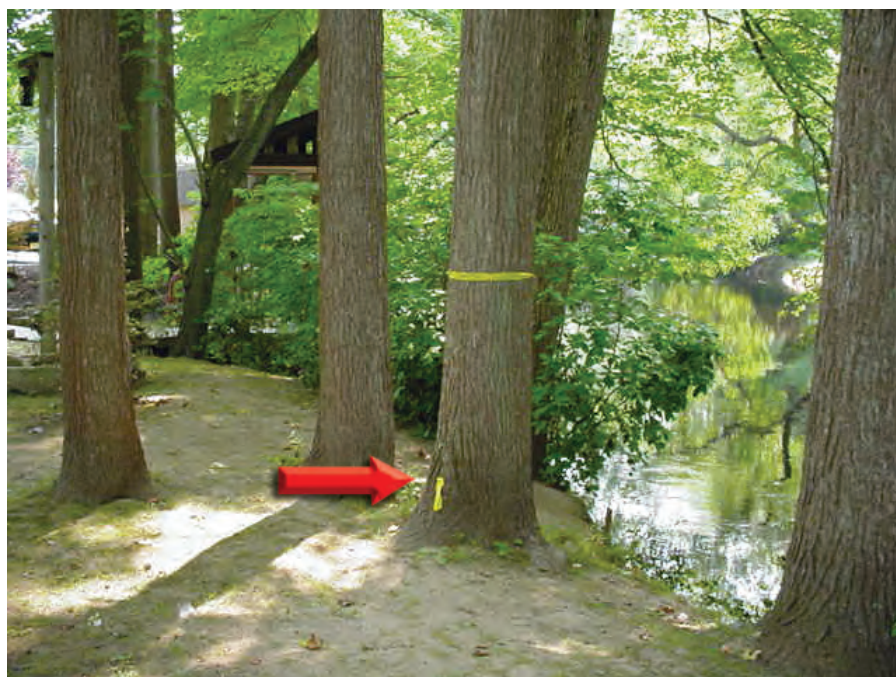
High-water mark on downstream, right bank of North Branch Rancocas Creek at Ewansville, N.J. (NBR3).

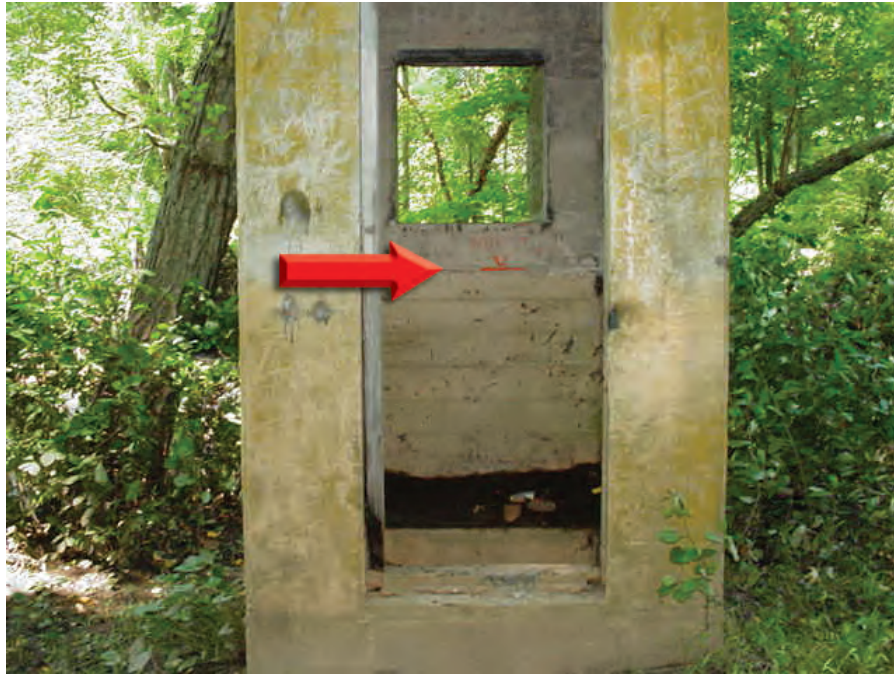
High-water mark in former gage house, 900 feet downstream from North Branch Rancocas Creek at Pemberton, N.J. (NBR5).

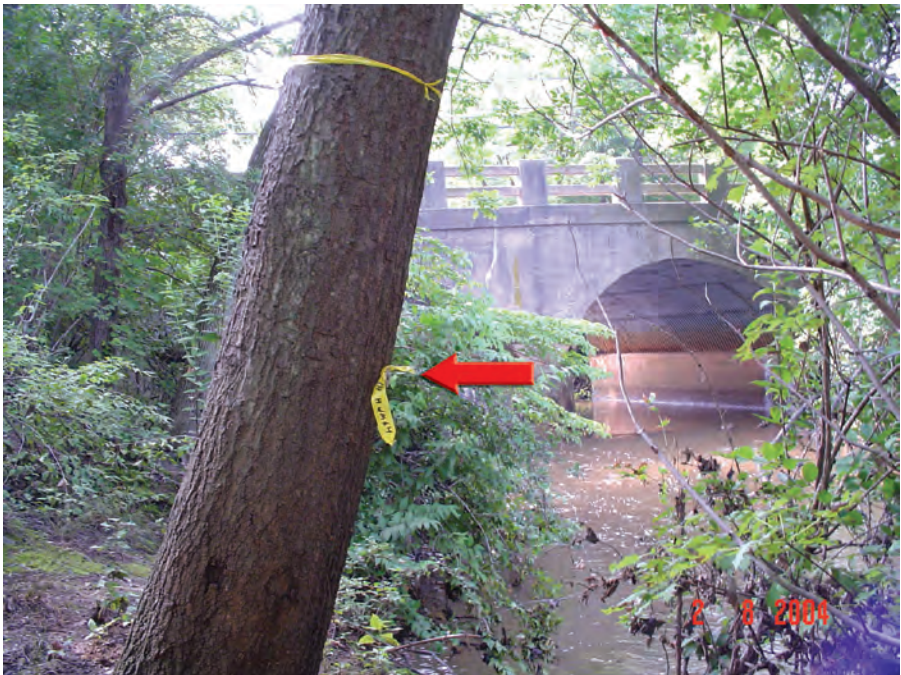
High-water mark on downstream right bank at North Branch Pennsauken Creek near Moorestown, N.J. (NBP1).

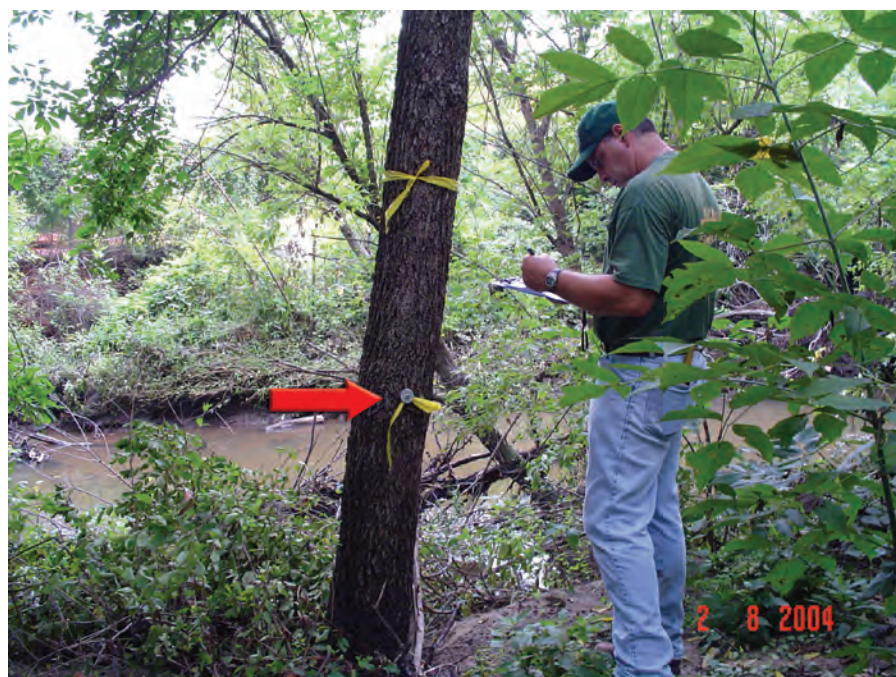
High-water mark on downstream left bank of South Branch Pennsauken Creek at Maple Shade, N.J. (SBP1).

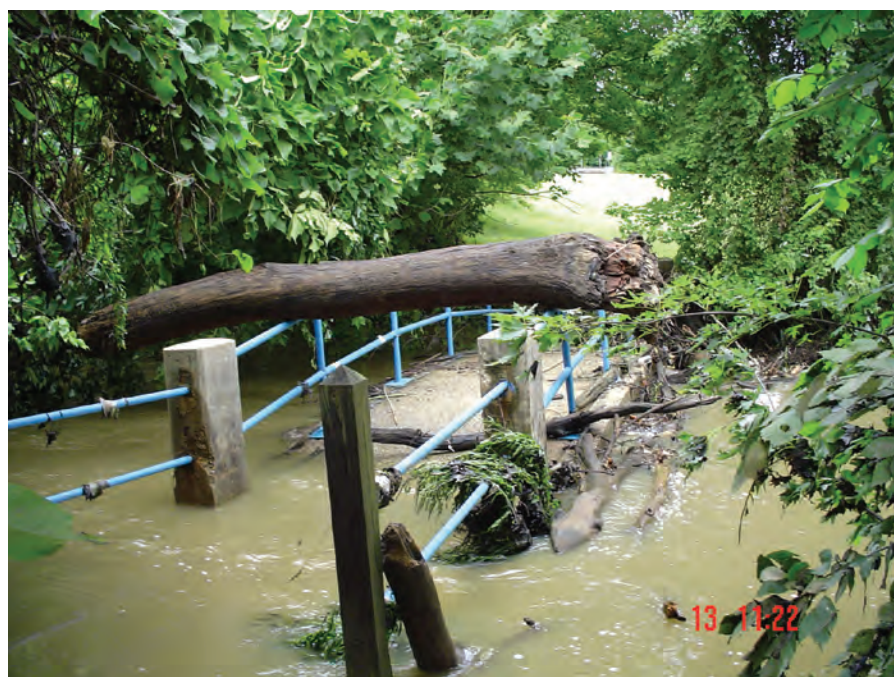
Footbridge, on the upstream side of Kings Highway, over the Cooper River at Haddonfield, N.J. (COP1), during the recession of the flood (July 13, 2004).

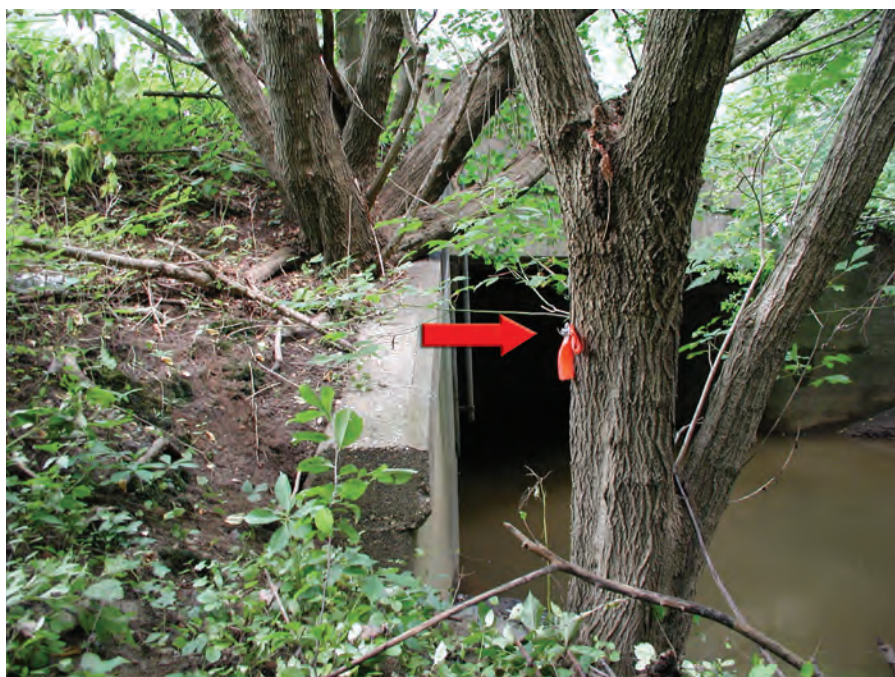
High-water mark on the downstream right bank of the North Branch Cooper River at Ellisburg, N.J. (NBC2).

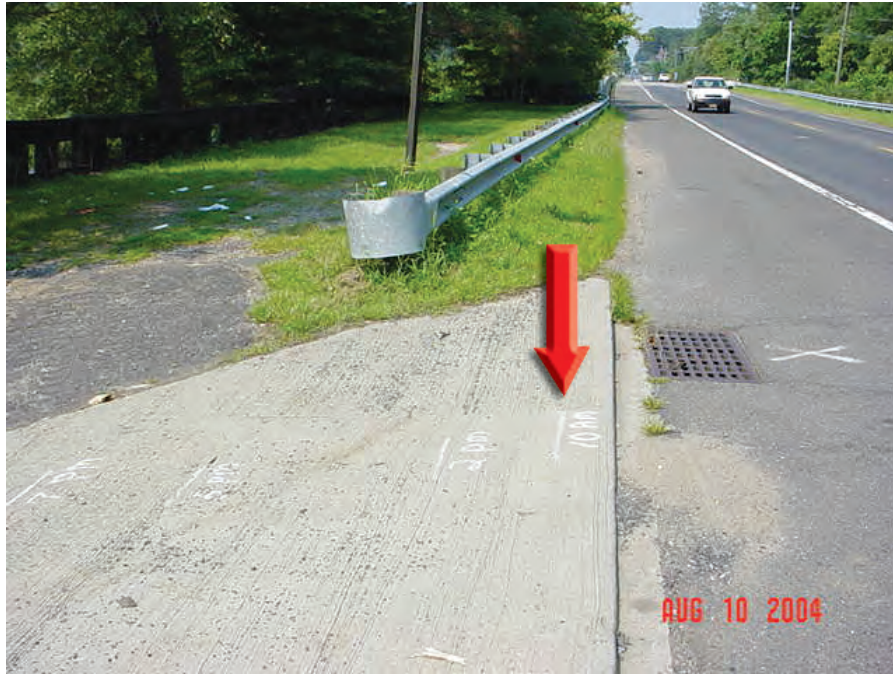
Site SBR0. Line painted on boat ramp (by unknown source) marking approximate crest of flood on the upstream right bank of the South Branch Rancocas Creek on Marne Highway (County Route 537) in Rancocas Heights, N.J. Photograph taken on August 10, 2004.

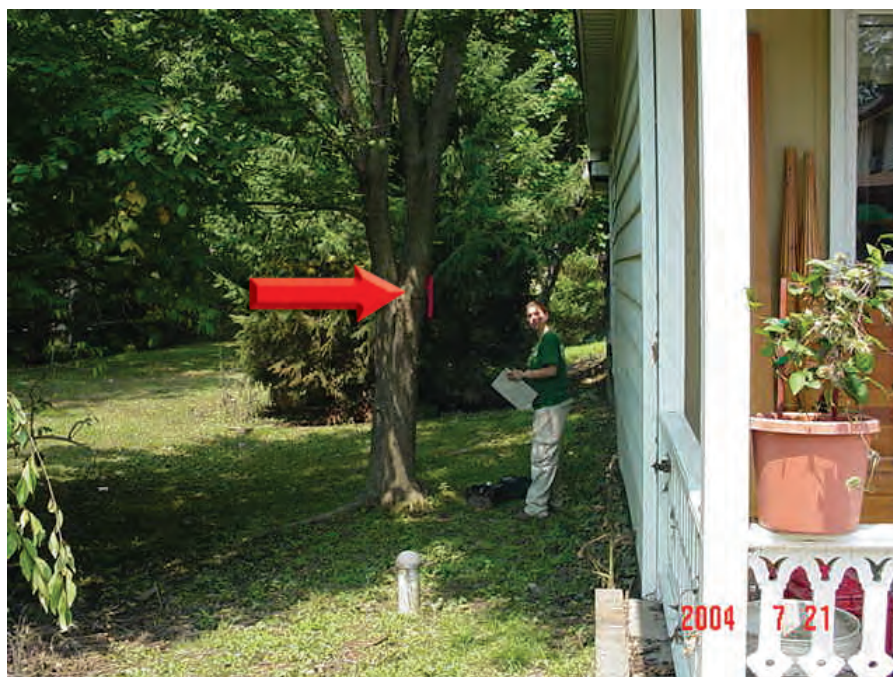
Site SBR4a. High-water mark on tree, downstream from Church Road (County Route 616) in Vincentown, N.J., on the right bank of the South Branch Rancocas Creek. Photograph taken on July 21, 2004.

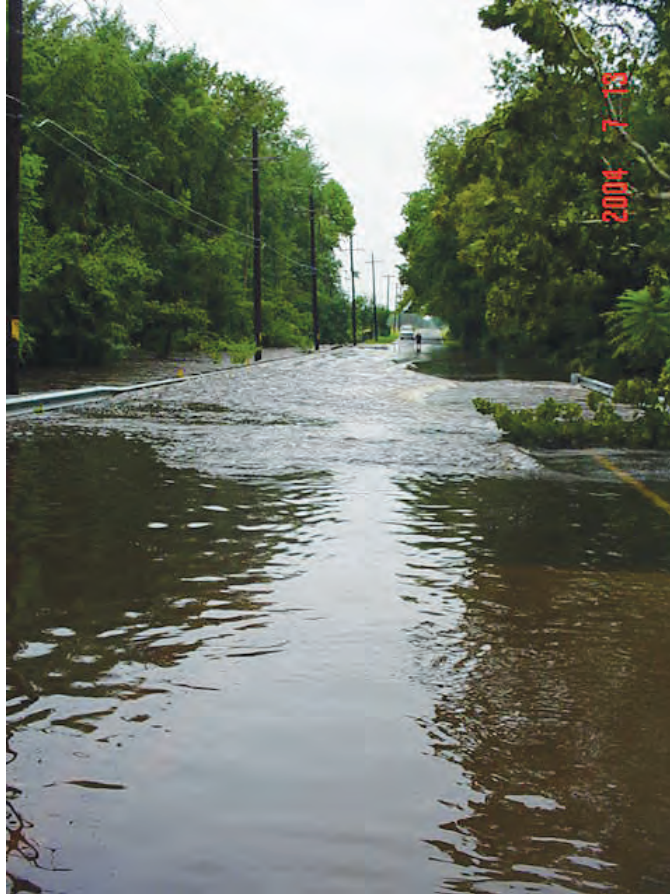
ite SBR3. Flow over Landing Street (County Route 641) in Vincentown, N.J. during recession of the flood. Photograph taken on July 13, 2004.

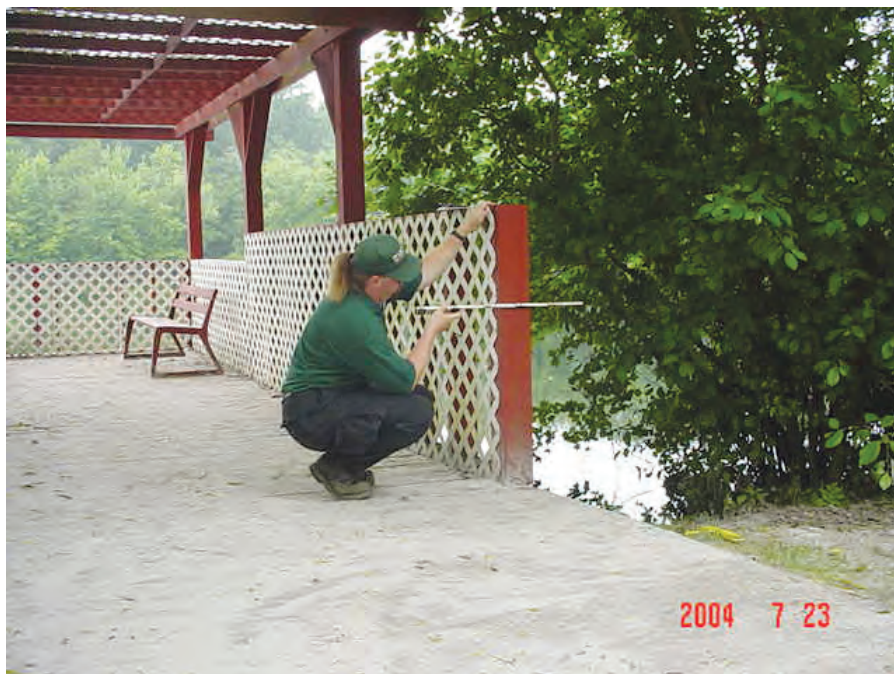
Site FRI3. High-water mark, downstream from State Route 70 on the right bank of Friendship Creek between Friendship and Red Lion, N.J. Photograph taken on July 23, 2004.

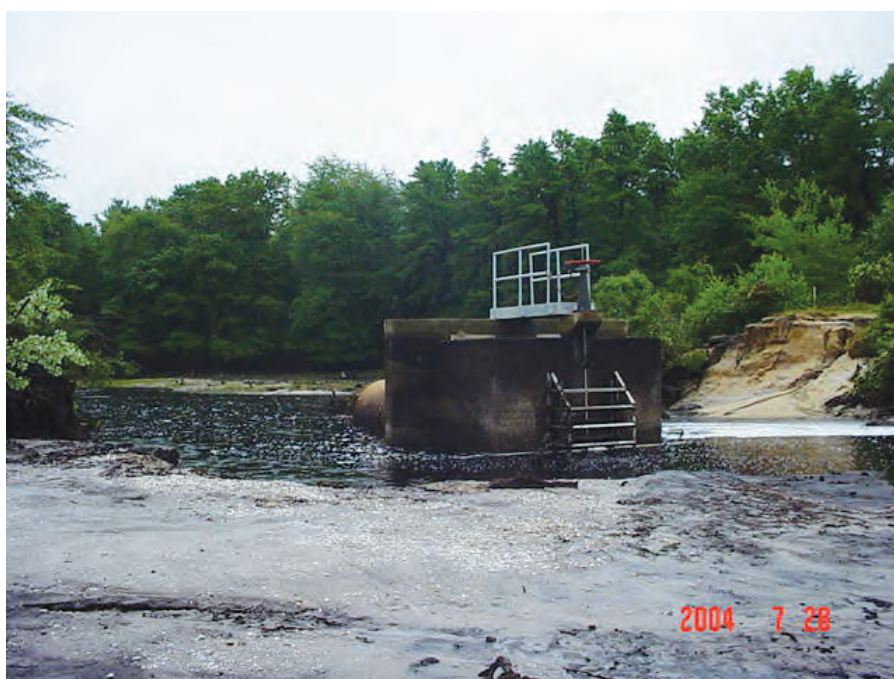
Site FRI6. Looking downstream at remnants of Middle Innawendiwin Dam on Friendship Creek in Friendship, N.J. Photograph taken on July 28, 2004.

| Stream reach | Dam name | Condition | Class | Municipality | Stream | Latitude and longitude (NAD 83) | |
|---|---|---|---|---|---|---|---|
| Friendship Creek | Camp Inawendiwin Middle Dam | Failed | L | Tabernacle Township | Friendship Creek | 39°51'50" | 74°41'13" |

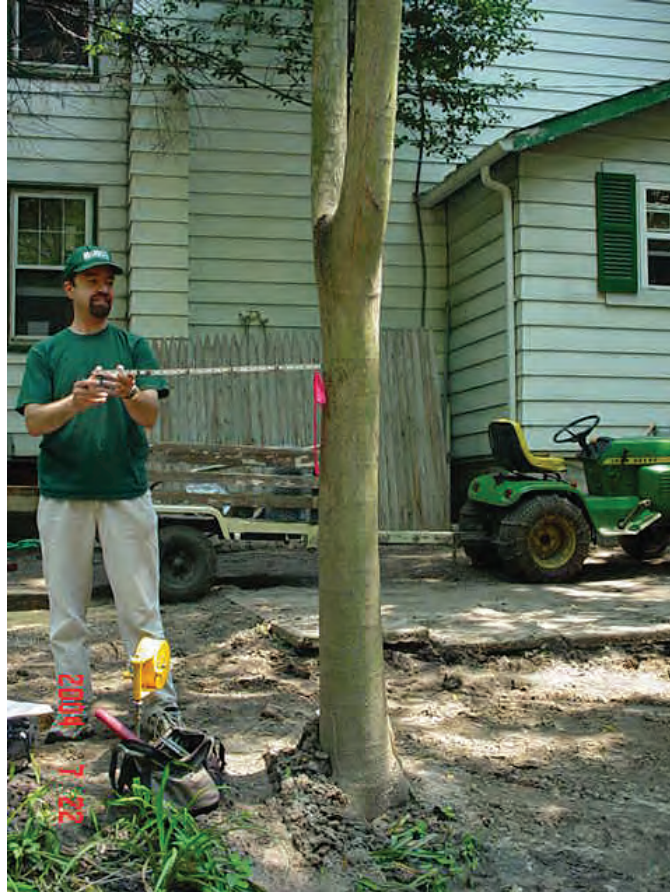
Site HAY1. High-water mark on Mimosa tree on downstream right bank of Haynes Creek at Himmelein Road in Oliphants Mills, N.J. Photograph taken on July 22, 2004.

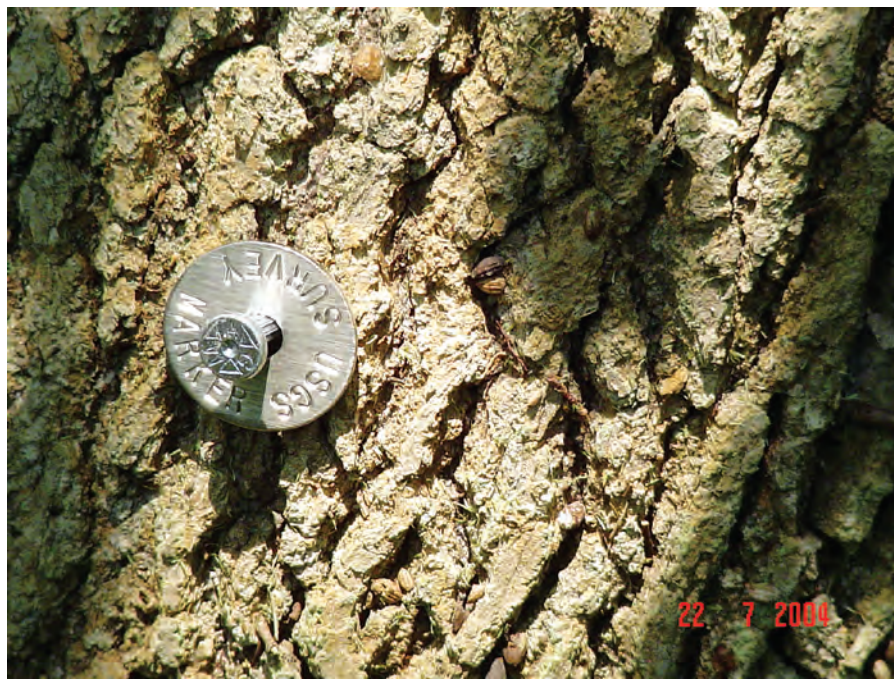
Site HAY4. USGS Survey Marker indicating seed line on tree, 500 feet downstream from Centennial Dam Road near Medford Lakes N.J., on the right bank of Haynes Creek. Photograph taken on July 22, 2004.

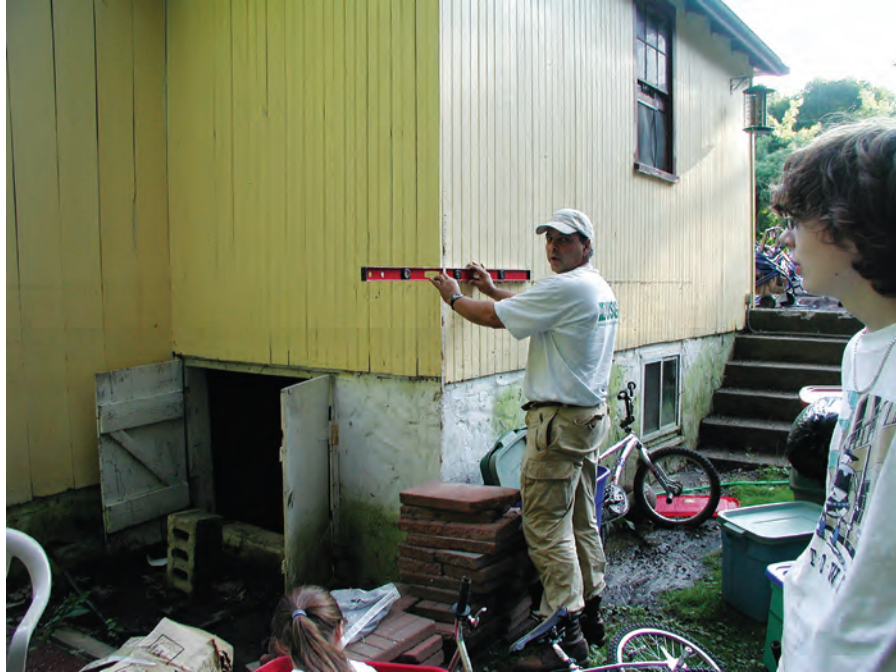
Site SWB4. High-water mark on garage on downstream left bank at Main Street bridge in Medford, N.J. Photograph taken on July 16, 2004. Ballinger Run.

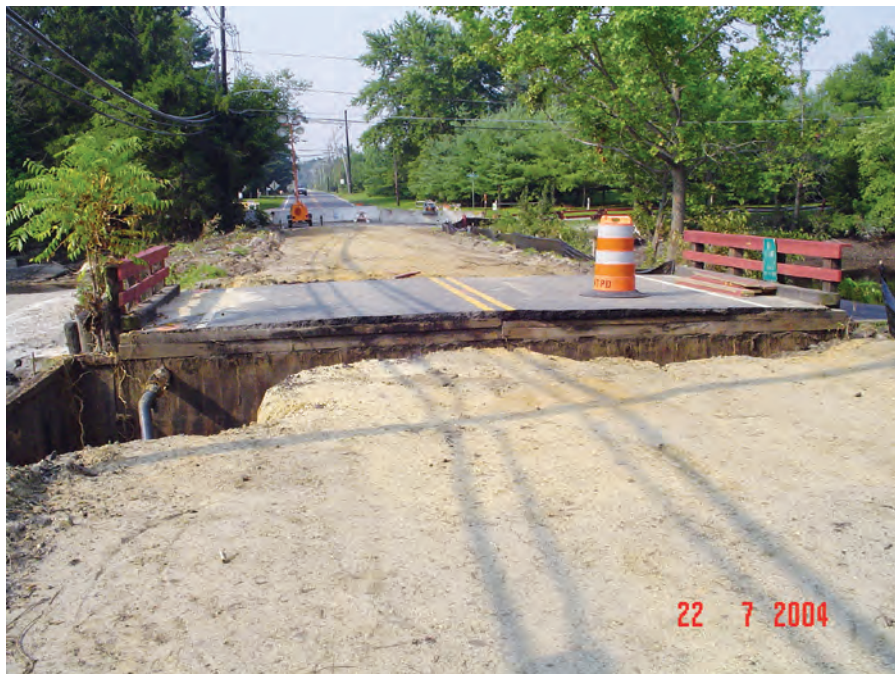
Site BAL3. Flood damage at the Jackson Road bridge over Ballinger Run in Medford Lakes, N.J. Dam upstream failed. Photograph taken on July 22, 2004.

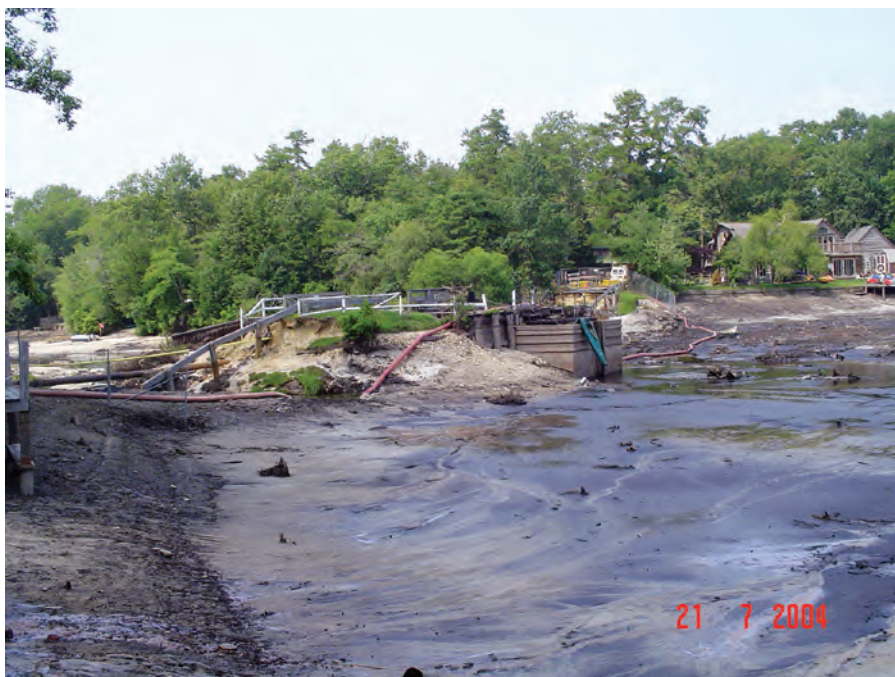
Site BAL5. Failed dam at Upper Aetna Lake on Beach Drive in Medford Lakes, N.J. Photograph taken July 21, 2004.

| Stream reach | Dam name | Condition | Class | Municipality | Stream | Latitude and longitude (NAD 83) | |
|---|---|---|---|---|---|---|---|
| | Upper Aetna Lake Dam | Failed | S | Medford Lakes Borough | Ballinger (Haynes Creek tributary 3) | 39°51'25" | 74°47'55" |

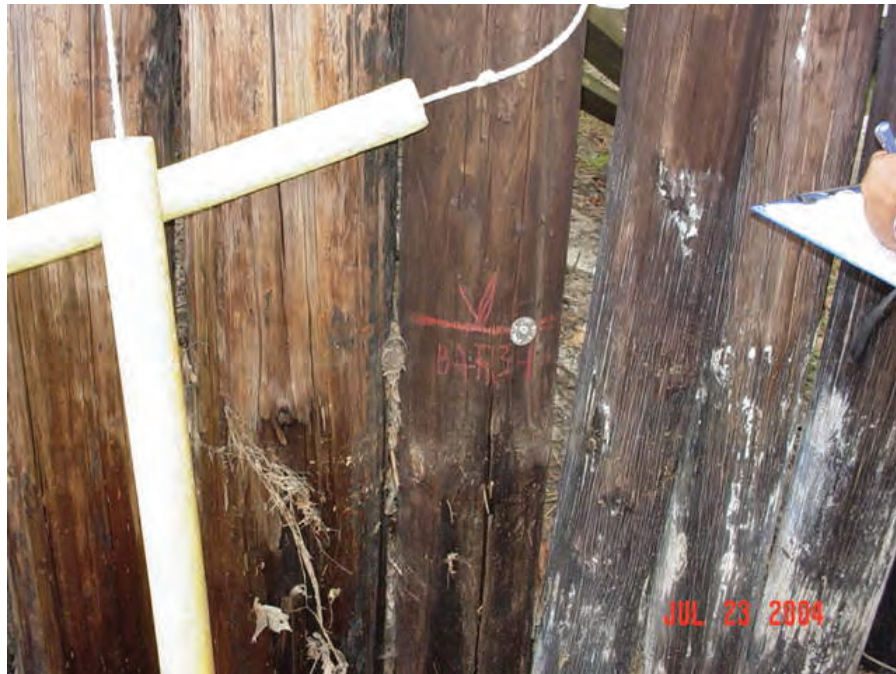
Site BAR3. High-water mark on bulkhead pilings on the upstream, right bank of Barton Run at Braddock Mill Road in Kresson, N.J. Photograph taken on July 23, 2004.

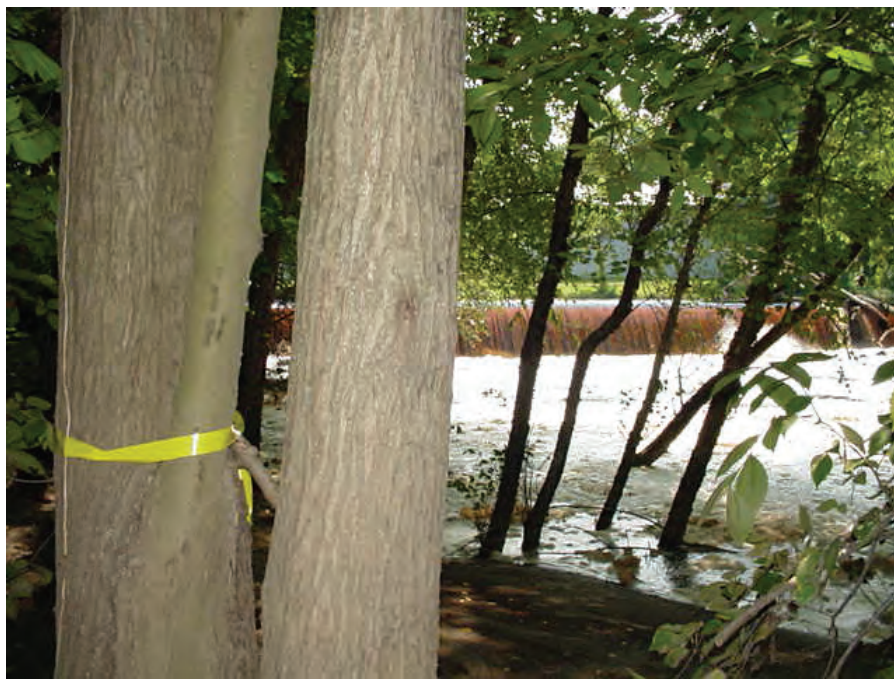
Site NBR5. High-water mark on tree in foreground and the North Branch Rancocas Creek flowing over the dam in the background near Hanover Street in Pemberton, N.J. Photograph taken on July 21, 2004

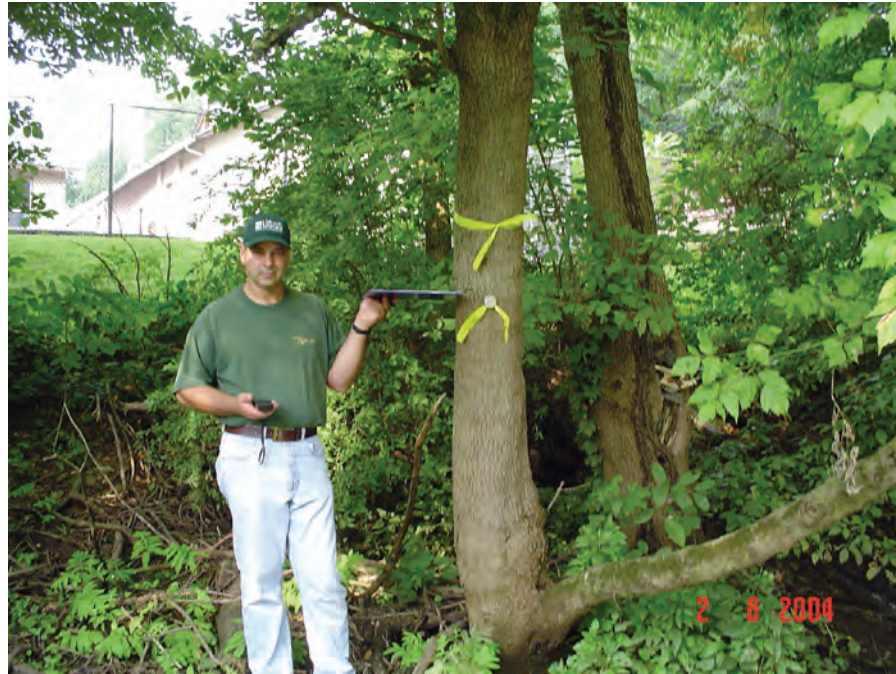
Site NBP1. High-water mark on tree, at upstream side of Kings Highway, on left bank of the North Branch Pennsauken Creek in Moorestown, N.J. Photograph taken on August 2, 2004.

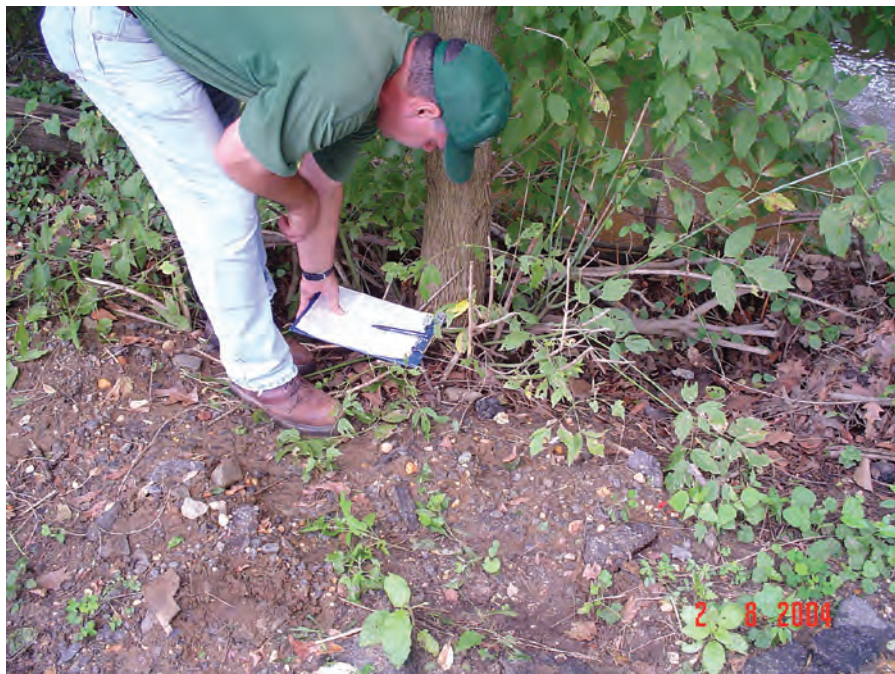
Site SBP1. High-water mark at top of right bank of the South Branch Pennsauken Creek, upstream of Kings Highway in Maple Shade, N.J. Photograph taken August 2, 2004.

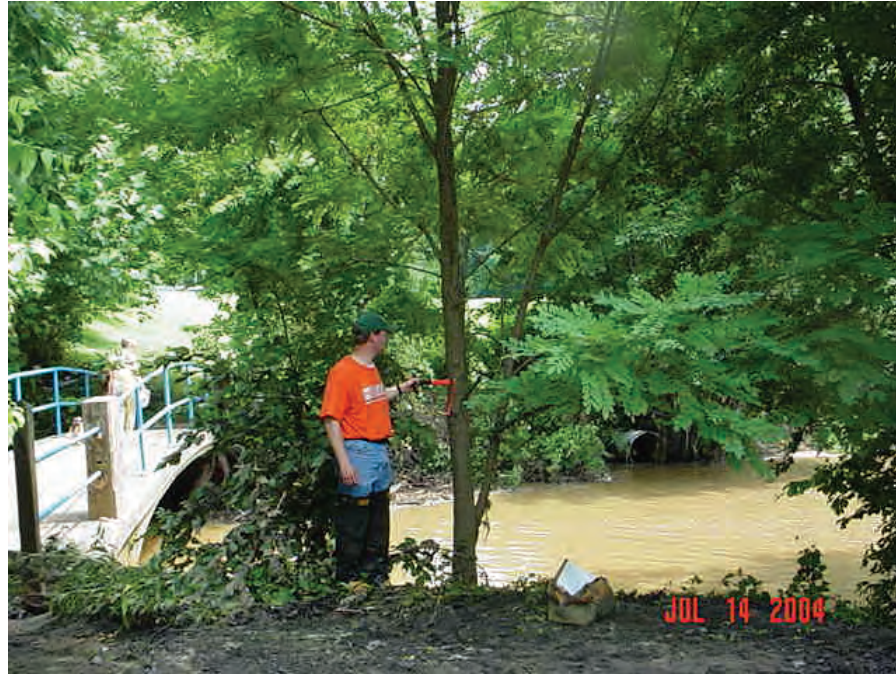
Site COP1. High-water mark on left bank, downstream from dam on Cooper River, upstream from Kings Highway (State Route 41) in Haddonfield, N.J. Photograph taken July 14, 2004.

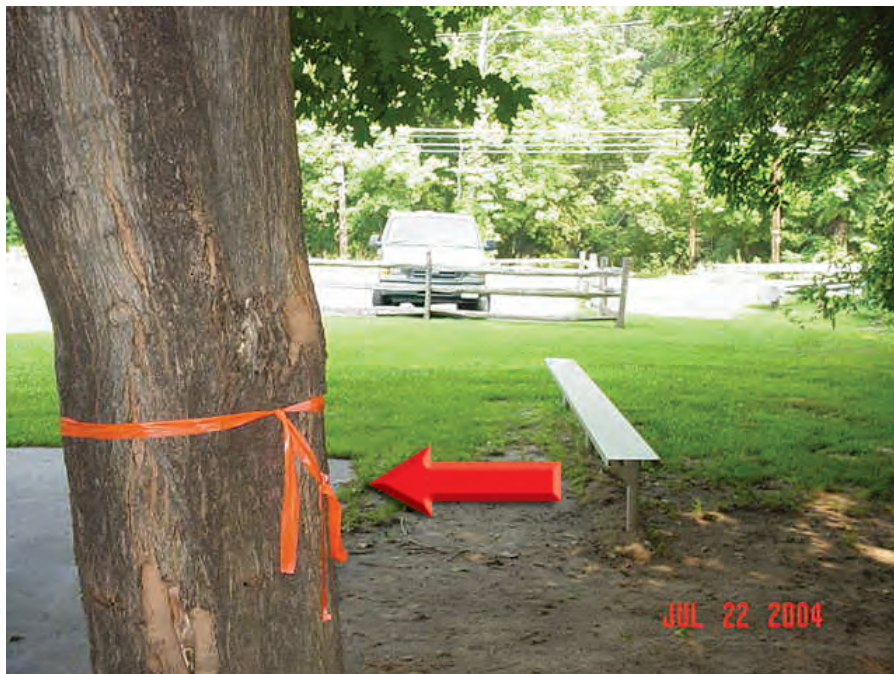
Site NBC4. High-water mark on tree, upstream side of Markkress Avenue on left bank of the North Branch Cooper River in Springdale, N.J. Photograph taken July 22, 2004.
